# 1964-66

## CONVERTIBLE TOP REPAIR MANUAL

MUSTANG — FALCON — COMET  
FORD — MERCURY

# SERVICING CONVERTIBLE TOPS

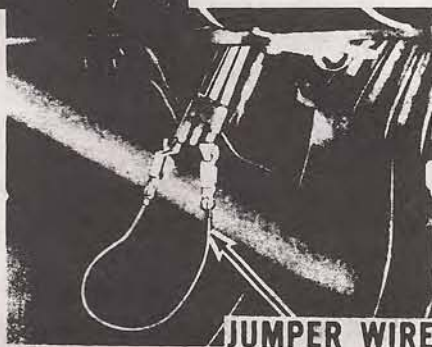
Figure 4—Jumper Wire For Switch Wiring

2. If there is power to the switch, connect a jumper wire between the black (feed) wire and the red wire, and then between the black and the yellow wire (Fig. 4). If the top motor operates, the switch is faulty and must be replaced.
